Development of a novel wheel-rail maintenance strategy utilizing laser cladding technology

- Doctoral Thesis -

Quan Lai

Monash University

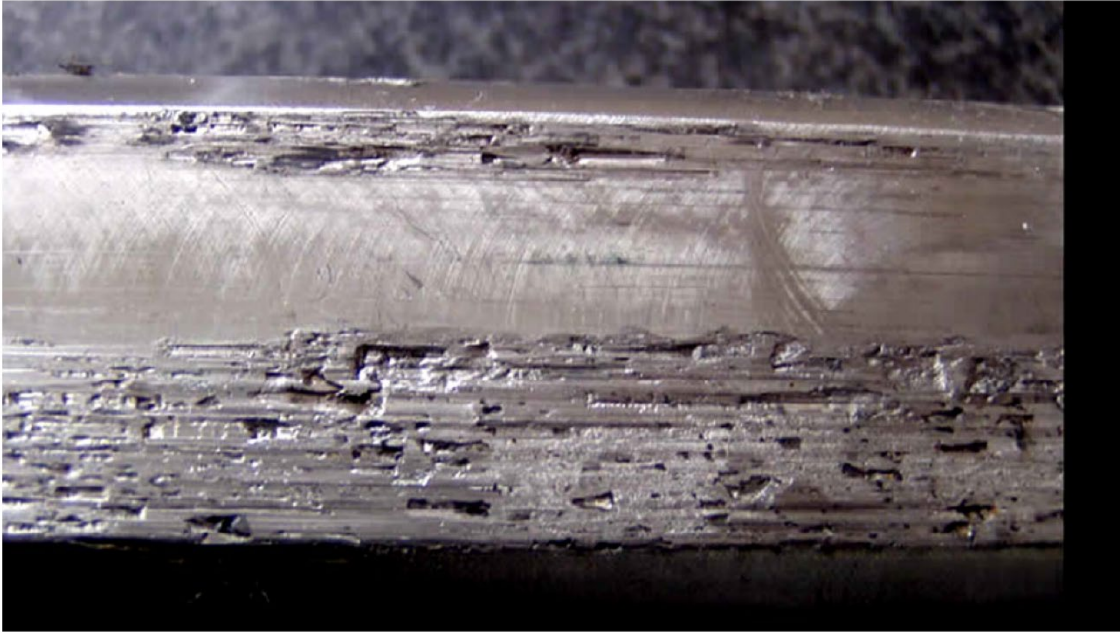
Figure 2-1 Abrasive wear (scratches) on rails. [2]

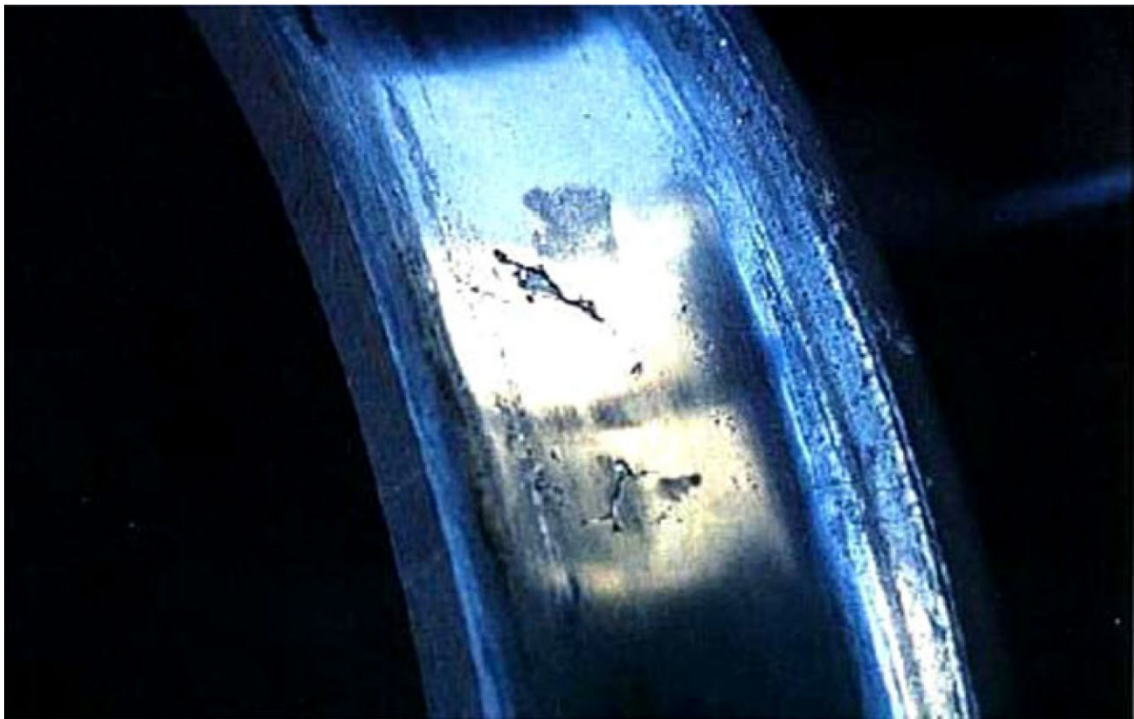
Figure 2-4 Delamination wear of wheels. [2]

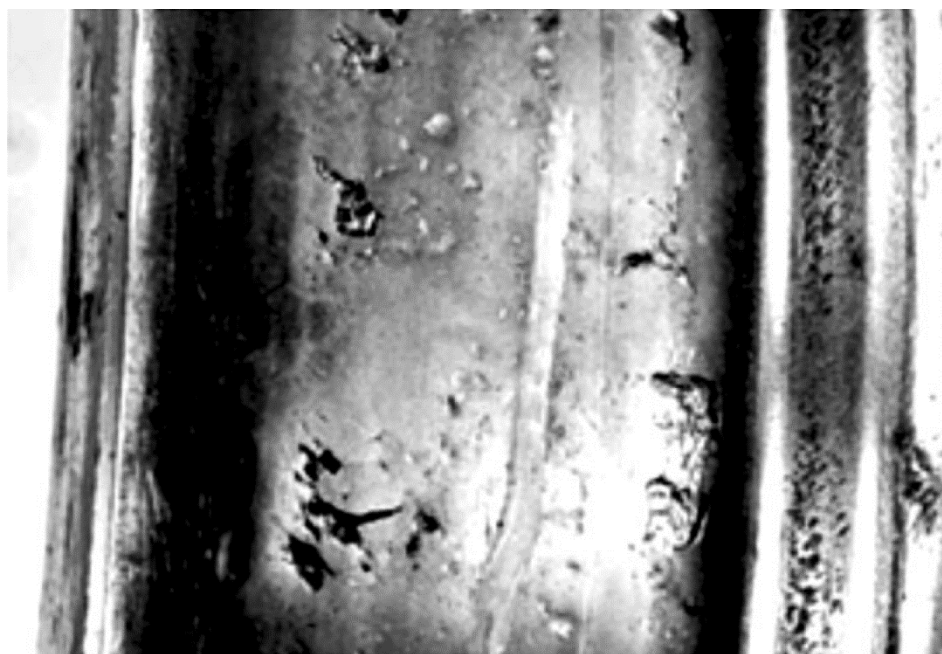
Figure 2-8 Wheel with surface fatigue mechanism. [2]

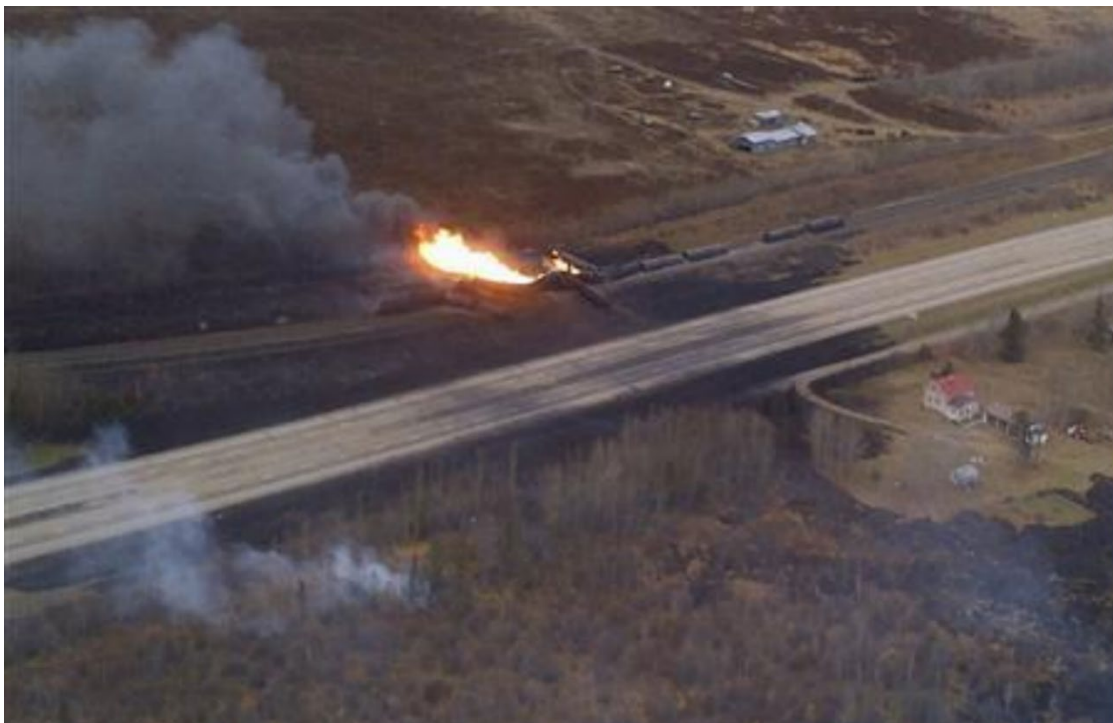
Figure 2-9 Train derailment in the town of Gainford, Alberta, Canada owing to surface defects.

In the railway industry, wear is the most critical issues. If remained untreated, catastrophic failures would happen rapidly. On October 19th, 2013, in the town of Gainford, Alberta, Canada, a freight train derailed and caused chaos, as shown in Figure 2-9. As this train had thirteen of its carriages containing crude oil and LPG (liquid petroleum gas), 106 homes were evacuated with one home damaged. A large section of the track, approximately 185m, was destroyed and upon investigation it was found that the high rail of this curve (approximately 550m radius) broke into several pieces as the rail was near its wear limits, displayed heavy surface fatigue and contained many transverse defects.

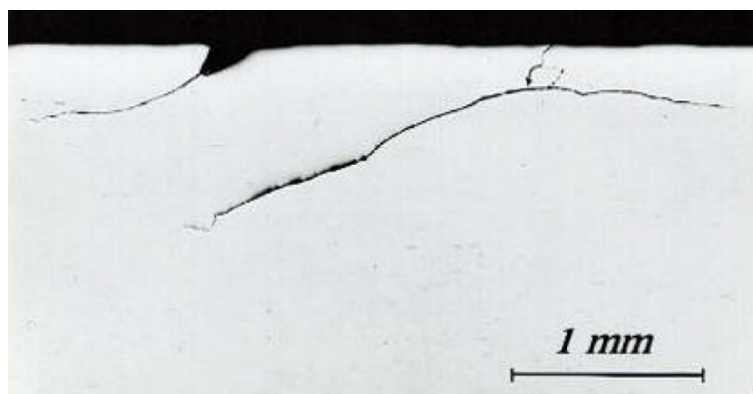
Figure 2-12 Cracks and spalls in initial stages develop in a rail longitudinal section. The crack propagates into the railhead and then level out. [1]

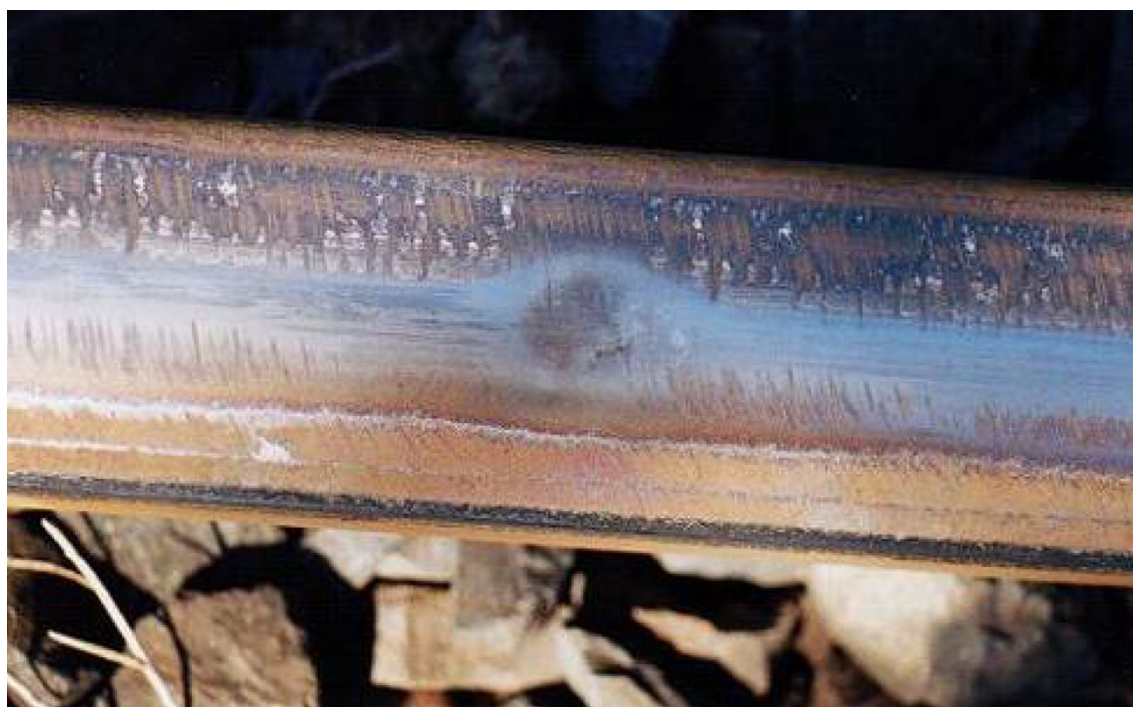
Figure 2-22 Initial stage of running surface squat. [1]

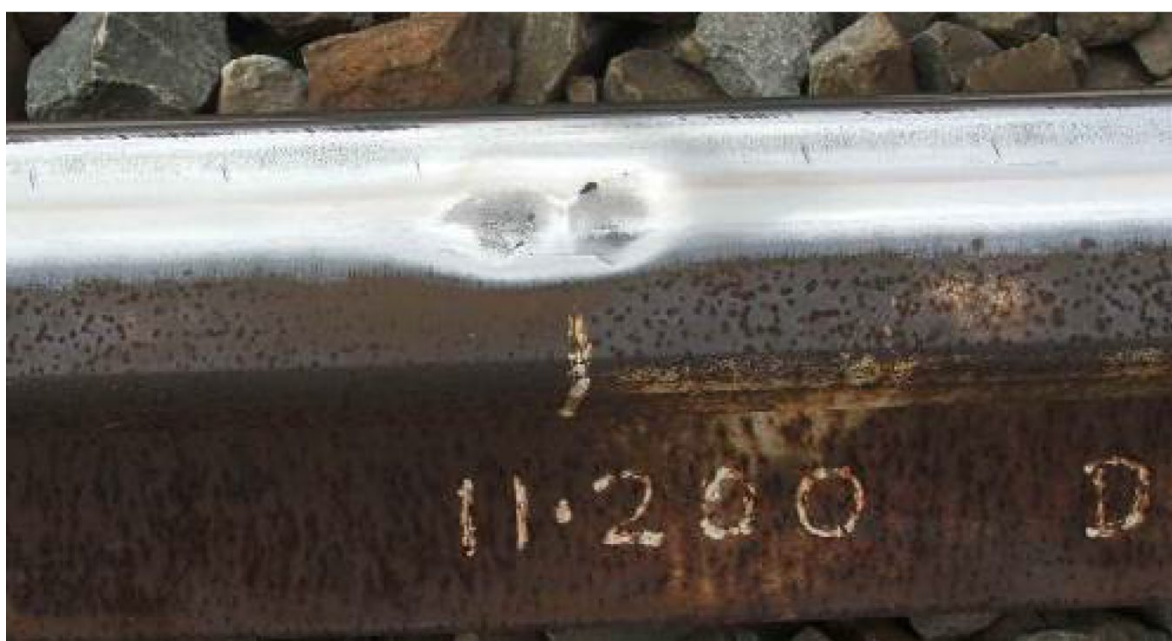
Figure 2-23 Intermediate stage of running surface squat. [1]

Squats are another common form of subsurface defects. Squat defects are subsurface laminations initiated from small surface cracks which can grow downwards to the rail feet at an angle of 20° - 30° to the rail surface. As approaching the depth of 4 - 6 mm, the cracks change its major propagation plane from rail-vertical to rail-horizontal plane, as shown in Figure 2-21. Two main types of squats are running surface squats and gauge corner squats. Running surface squats are generated by combined effects of thermal traction and wheel slip, as a result, this squat type can occur any place in the contact patch. Gauge corner squats are initiated by previously-formed cracks, particularly cracks formed by surface RCF defects, thus the squats are often found near the gauge corner, on the curves of high rails and in turnouts. Figures 2-22, 2-23 and 2-24 show respectively initial, intermediate and severe stages of running surface squats. Figures 2-25, 2-26 and 2-27 show respectively initial, intermediate and severe stages of gauge corner squats.

Squats can be spotted by a darkened area on the rail surface, which is attributed to surface depression and reduction in polishing by train wheels. In running surface squats, shape of a double-sided kidney is commonly detected. However, some irregular shapes can also be found. Some triangular surface cracks may be found in both gauge corner and running surface squats. Shape of gauge corner squats will be changed after a rail-grinding, as shown in Figure 2-28.

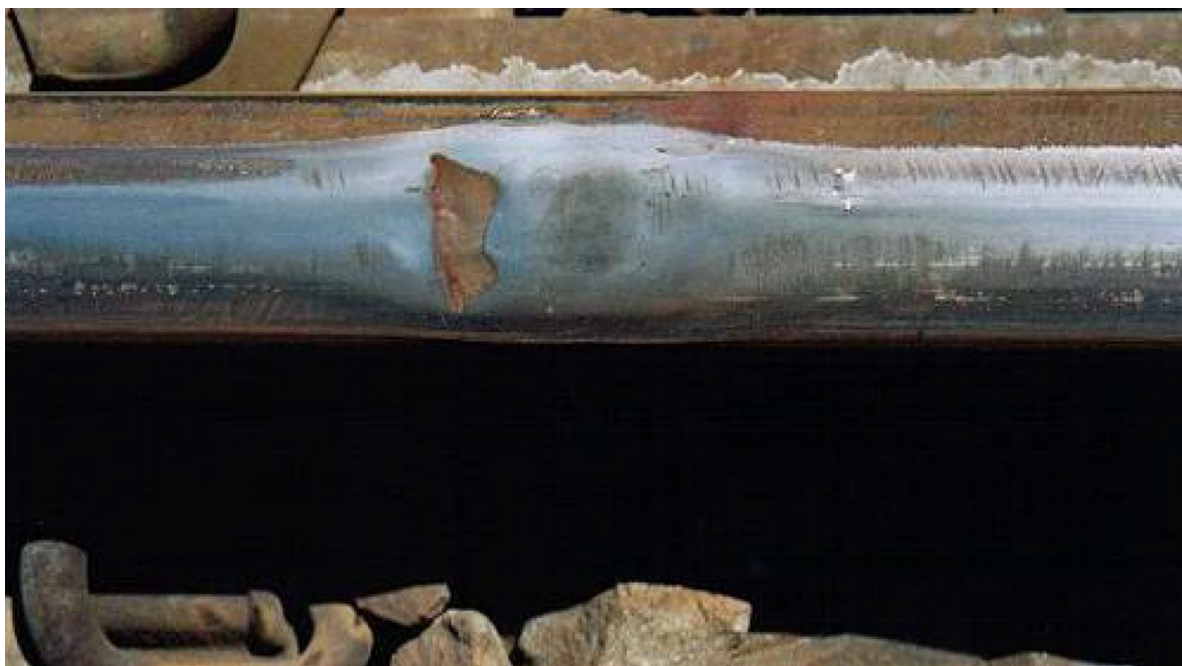
Figure 2-24 Severe stage of running surface squat. [1]

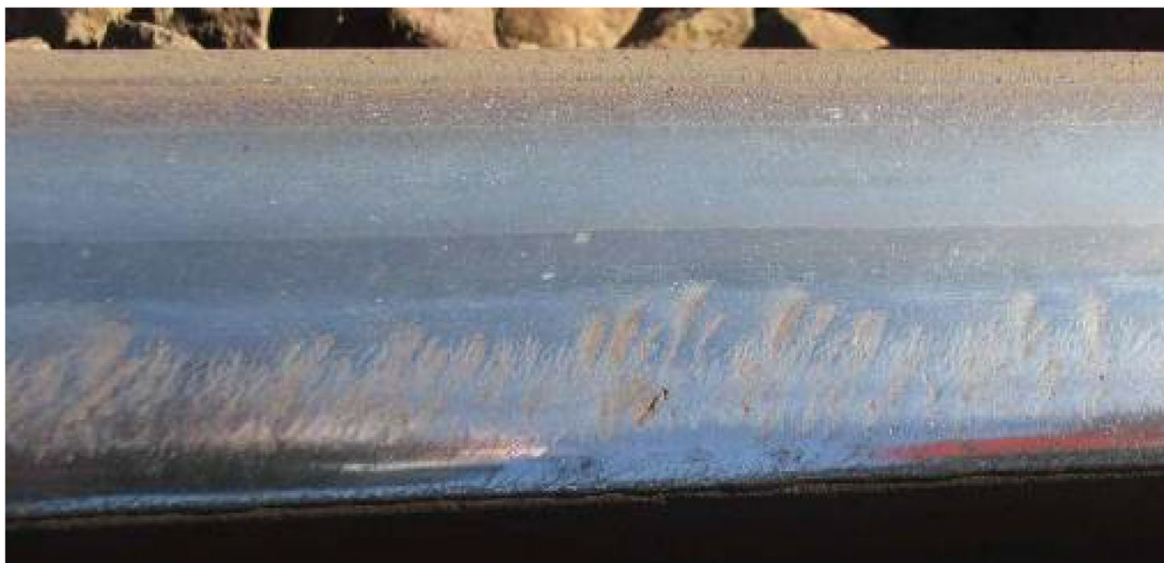
Figure 2-26 Intermediate stage of squats initiated by gauge corner checking. [1]

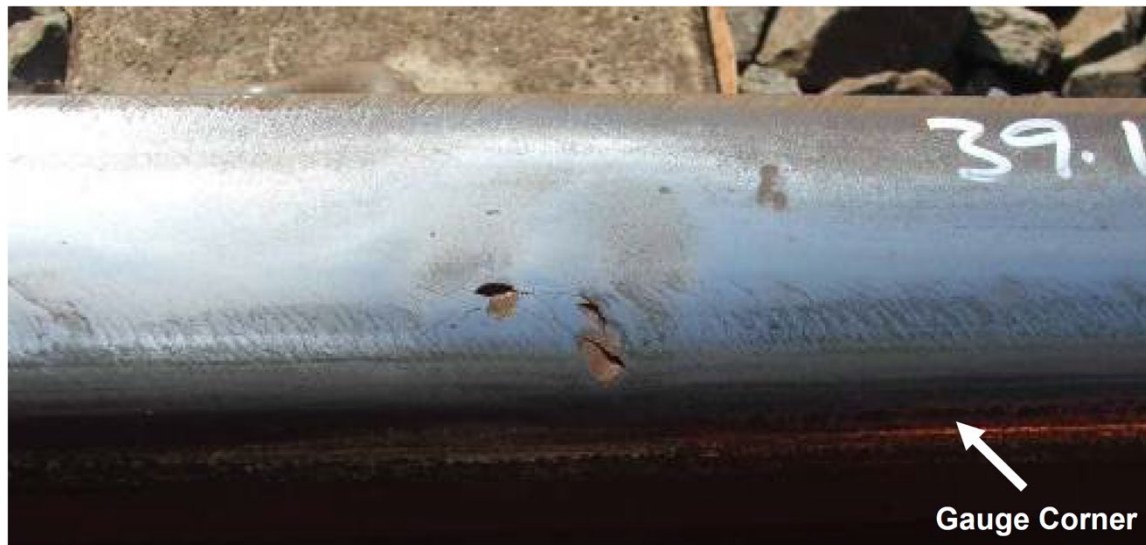
Figure 2-27 Severe stage of squats initiated by gauge corner checking. [1]

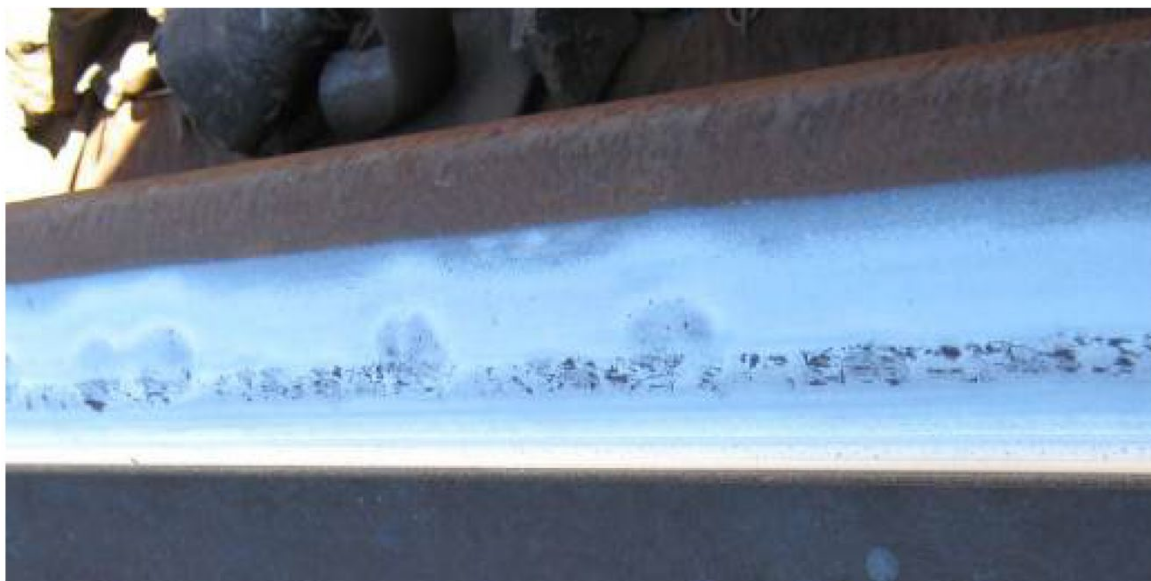
Figure 2-29 Running surface squats initiated from wheelslip. [1]

Confusions between squats and wheelburn defects can be avoided by recognizing the primary different features. Squats are established via several stages over a long period of time, whereas wheelburns is an instant and sudden defect after an incident of wheel slip. Moreover, wheelburns do leave matching defects on the opposite rail, whereas squats do not. Figure 2-29 shows an image of typical running surface squats initiated from wheelburn.

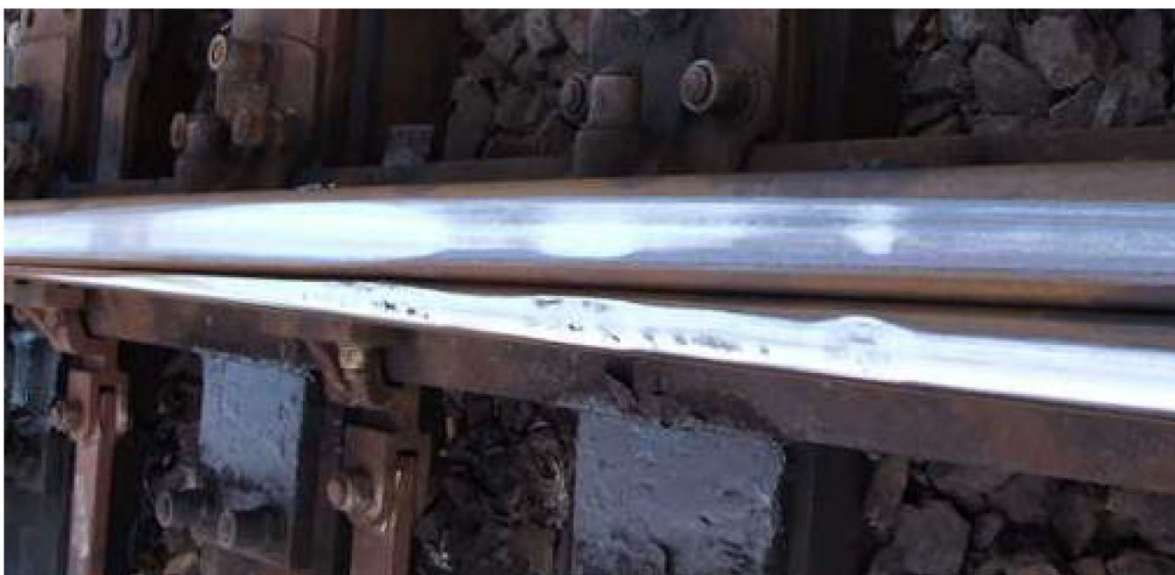
Figure 2-30 Squats in switches. [1]

Squats occur likely in curved track with radius of 800-1600m, specifically in the transitions of sharp curves and on the high rail in the curved track. Squats may also appear in unacted rails in turnouts, both passenger and/or freight lines, all types of sleepers and rail and both Standard Carbon (SC) and Head Hardened (HH) rails, as shown in Figures 2-30 and 2-31. Squats are not found in tunnels unless there is water present. The actual length and depth of the subsurface squats can be easily determined using an ultrasonic depth gauge, as shown in Figure 2-32.

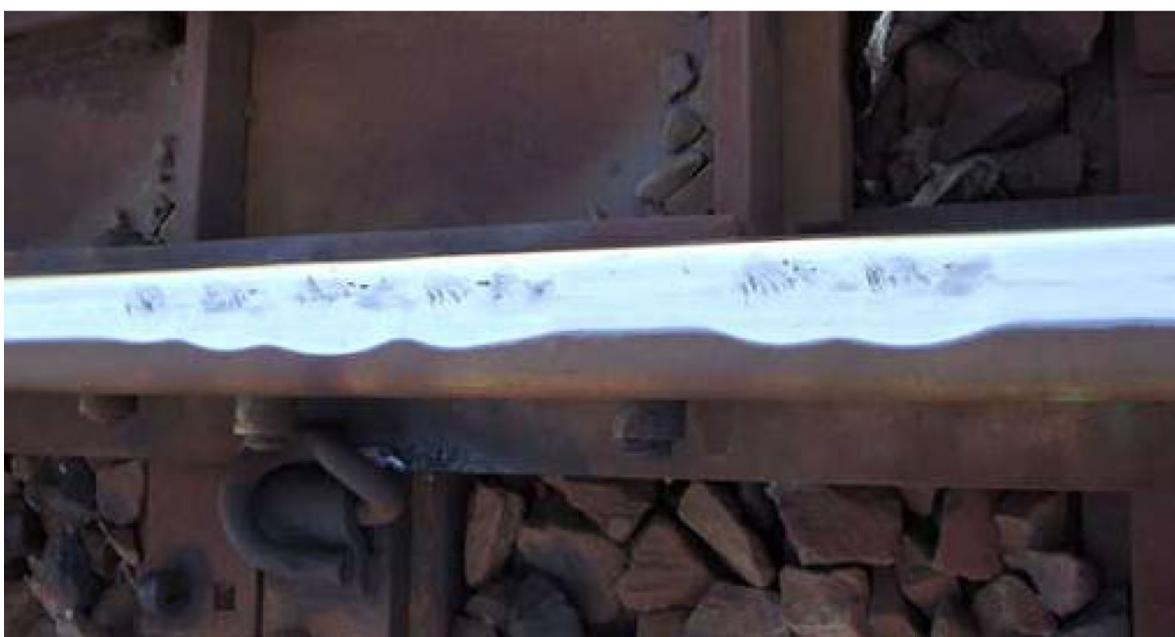
Figure 2-31 Squats in turnout. [1]

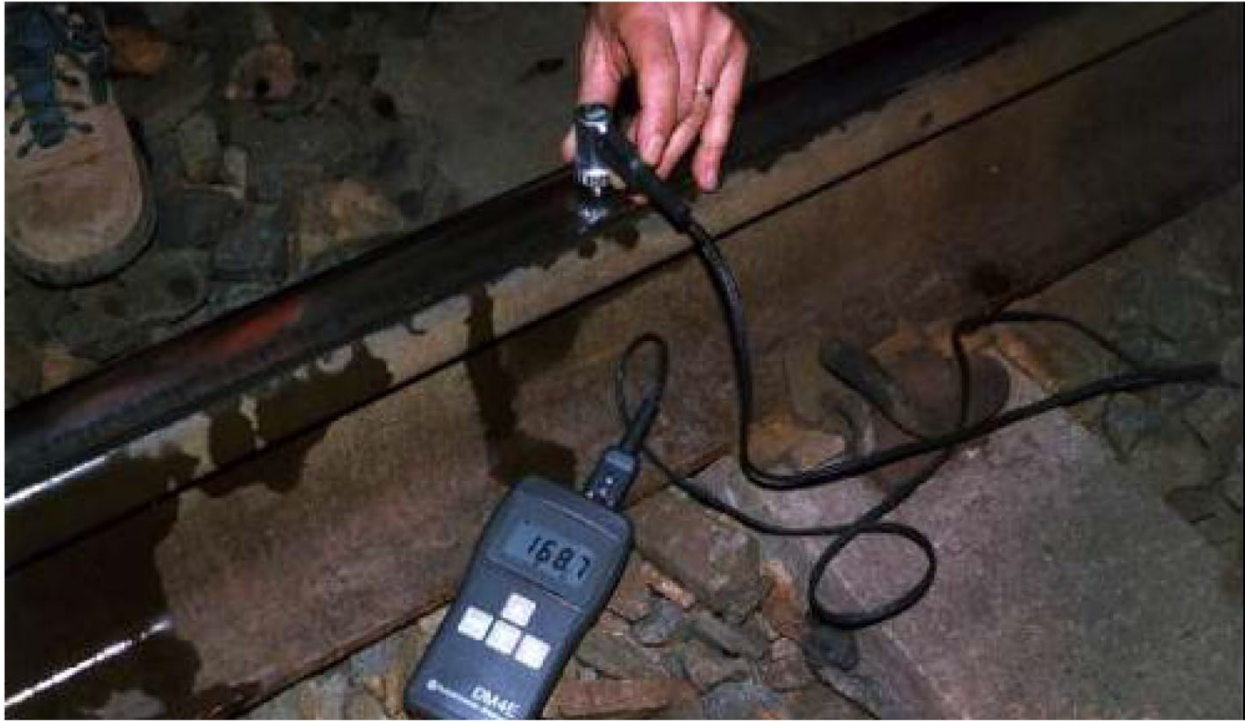
Figure 2-32 Inspection to determine the length and depth of subsurface squat cracks using an ultrasonic depth gauge. [1]

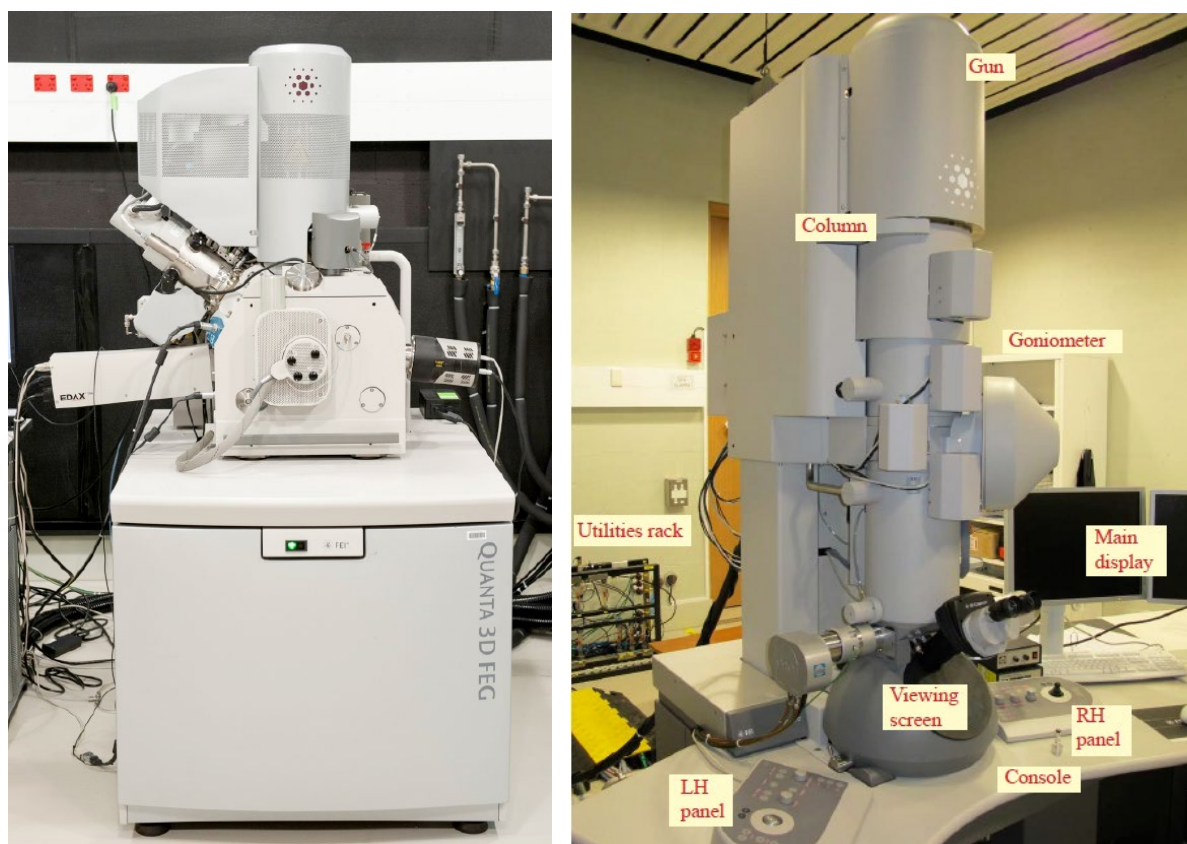
Figure 3-7 (a) Metallurgical sample preparation using FEI Quanta 3D FIB workstation. (b) Detailed microstructural investigation using the FEI Tecnai G2 F20 S-TWIN microscope.
