Fracture and Fatigue Mechanism of Cast Iron Water Mains

A thesis submitted in fulfilment of the requirements for
the degree of Doctor of Philosophy

Department of Civil Engineering

MONASH University

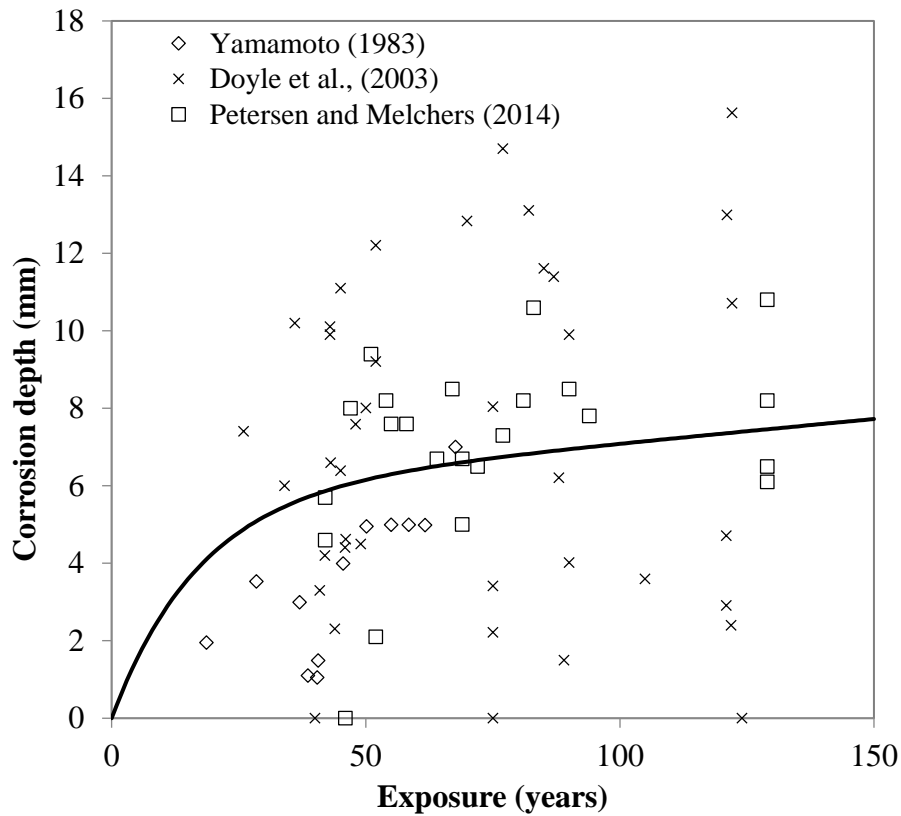
Figure 2- 3 Corrosion depths with exposure of CI water pipes

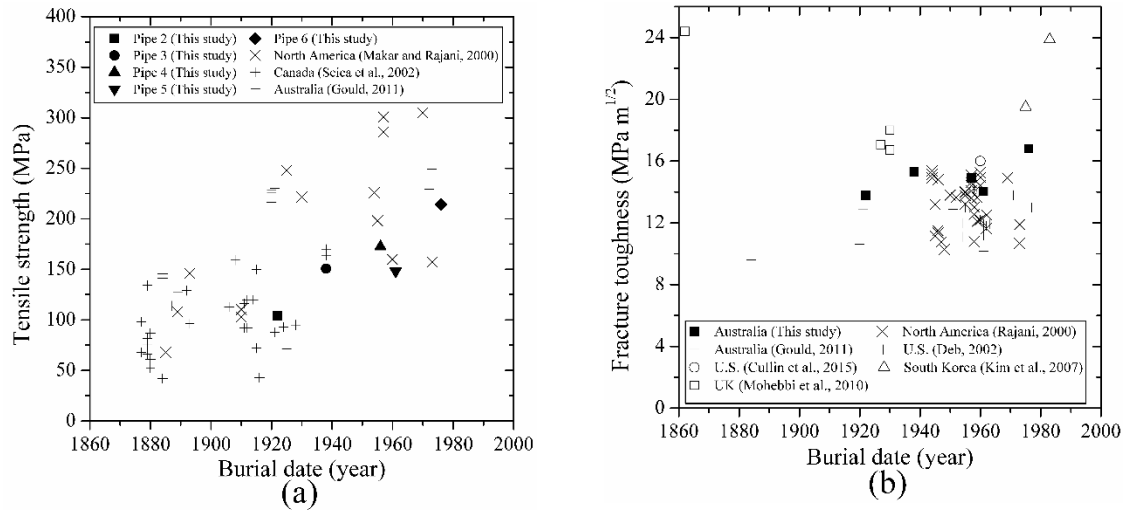
Figure 3- 3 (a) Tensile strengths (MPa) of CI pipes with burial date (year). (b) Fracture toughness (MPa m^{1/2}) of CI pipes with burial date (year)

The fracture toughness test results and literature data are plotted against construction date in Figure 3(b) (Cullin et al., 2014; Deb, 2002; Gould, 2011; Kim et al., 2007; Mohebbi et al., 2010; Rajani, 2000) and the average fracture toughness values tested in this study were similar to those recorded in the literature.

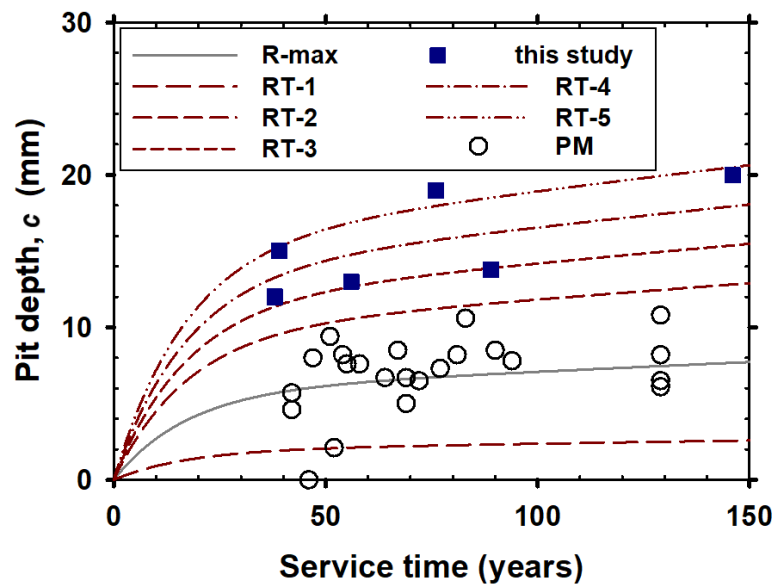
Figure 3- 7 External corrosion pit propagation curves (assuming $t_0 = 0$) and data from research literature with the data from present study

The data on maximum pit depth measured in this study, as well as the pit depth propagation curves calculated using Equation 3.4 from the corrosion related parameters (r_s , c_s , τ) suggested by Rajani (2000) and Rajani and Tesfamariam (2007), summarised in Table 3-7, are shown in Figure 3-7.

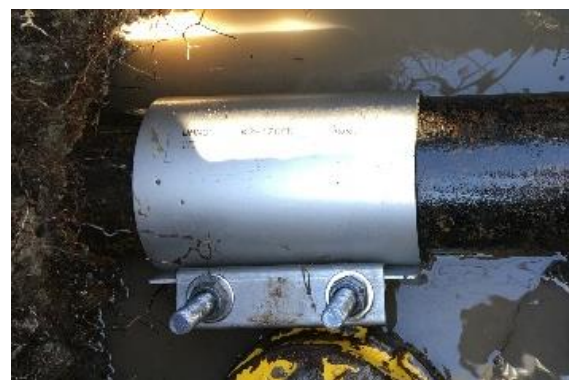
Figure 4- 13 (a) Leakage of a 100 mm-diameter CI pipe through a circumferential crack; (b) Tightened clamp in a leaking CI pipe
